# Manhole Inspection Summary

Manhole # S41I\_\_029MH

Insp Date: **5/14/08 9:56 AM**

**Location** Address: **1400 eastern ave**

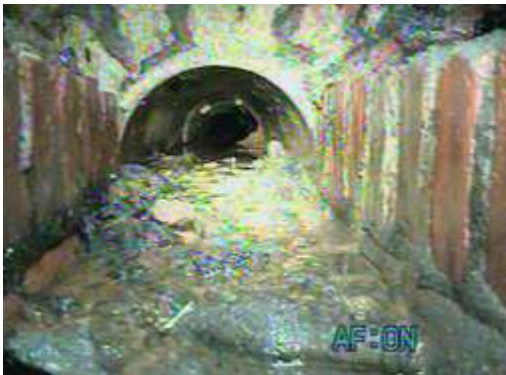
Defect 2

Condition: ☐ Sound ☐ Cracked ☐ Root Intrusion ☐ Deteriorated ☐ Leaks ☒ **Debris**

channel cond debris

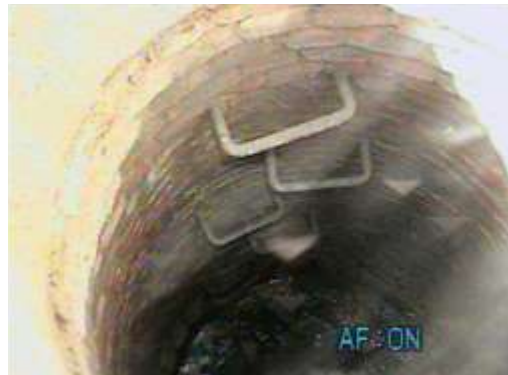
Defect 1

Count: **5** Missing: **0** ☒ **Corroded**

steps

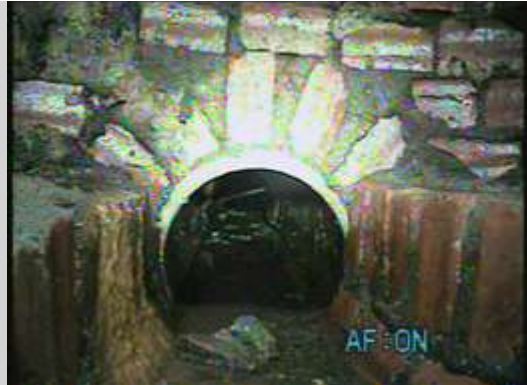
12 O'Clock Outflow

8 in. Circular Gravity Sewer  
Pipe Out @ 12 O'Clock

Deposits: ☒ None ☐ Mud ☐ Sludge ☐ **Debris** ☐ Grease

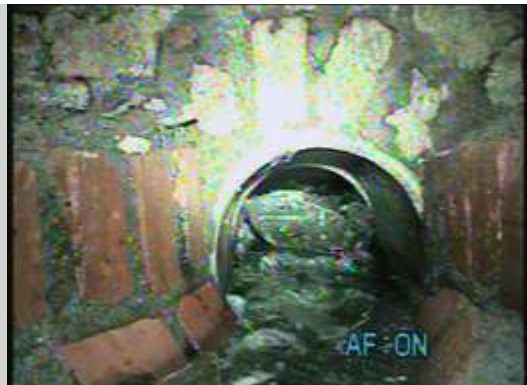
3 O'Clock Inflow

8 in. Circular Gravity Sewer  
Pipe In @ 3 O'Clock

Deposits: ☐ None ☐ Mud ☐ Sludge ☒ **Debris** ☐ Grease

Silt Depth: 5 (in.) Deposits Extent: **Heavy**

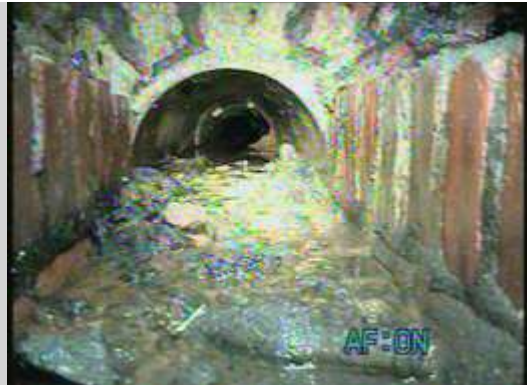
6 O'Clock Inflow

Pipe In @ 6 O'Clock

Deposits: ☐ None ☐ Mud ☐ Sludge ☒ **Debris** ☐ Grease

Silt Depth: **3** (in.) Deposits Extent: **Medium**
